REGIONAL FEATURES OF THE BRICK ART NOUVEAU DIRECTION IN THE ARCHITECTURE OF THE CITY OF KHARKIV

Abstract. The article considers the issue of stylistic attribution of buildings with decorative brickwork of facades within the Art Nouveau style in the city of Kharkiv. Modern trends in the reconstruction and preservation of facades of city's historical buildings, in general, are considered. Negative trends in the state of preservation of the original image, integrity and completeness of facade solutions, even of buildings-architectural monuments of the city of local importance, are identified.

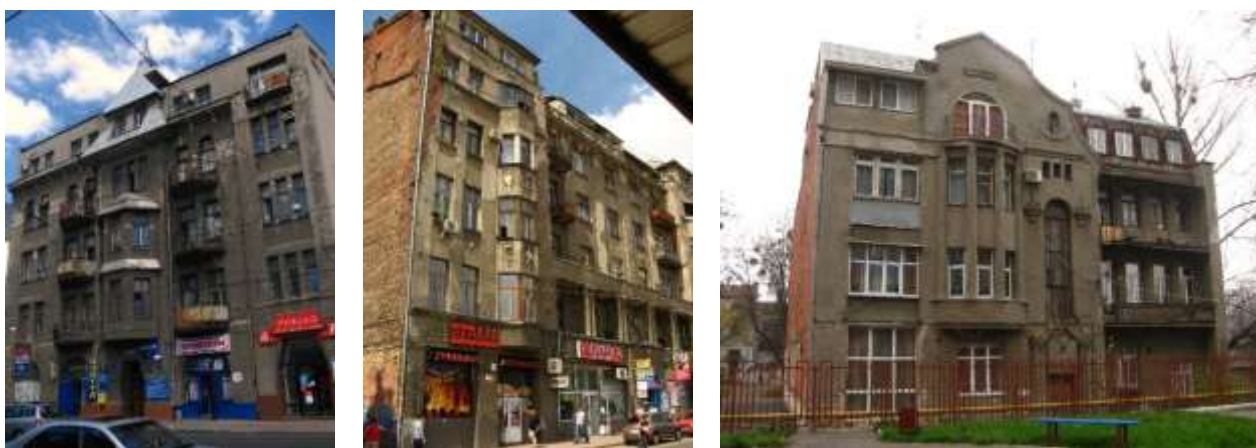
Fig. 1. Additions that disrupt the composition & the “grayness” of plastered facades (left to right): 46 Poltavsky Shlyakh St., 3 H.Skovorody St., 8 Maika Yohansena St.

The Second World War and the bombing of the city destroyed some of the buildings 80 years ago, which were subsequently demolished. Soviet tasks in the post-war period were rather concentrated on the functional component, moreover, for a long time in the official cultural studies, subordinated to the ideological center, the Art Nouveau era was considered a decadent manifestation of bourgeois culture [19, p. 7, 10], and, consequently, examples of art of this period were not included in the category of valuable and worthy of preservation. For many low-rise buildings erected in Kharkiv, a town that just had been gaining strength at the beginning of the last century, that fact has reflected in the unceremonious raising of additional floors, simplifying reconstructions, that led to losses of the fundamental characteristics of Art Nouveau architecture: proportions, division, scale, silhouette of the facade completion, game of textures, use of attic floors, roof slopes as an element of the facade solution. In general, the composition and aesthetic value of many facades has been violated (Fig. 1). Cement and sand plaster, colloquially called “fur coat,” was widely used to cover huge wall surfaces entirely, along with moldings, sculptural decor, and masonry features, and the facades became uniformly gray (Fig. 1).

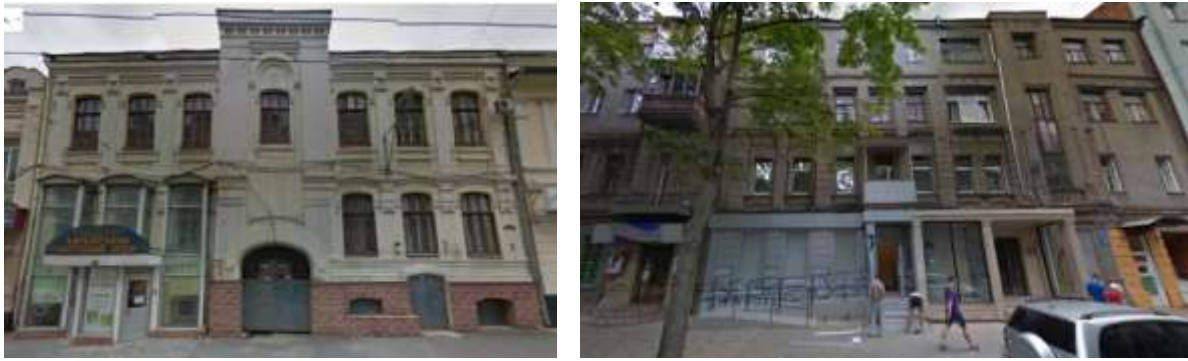
Fig. 2. Disharmonious elements of facades - extensions, superstructures:
5 Korolenko lane, 12 Gudanova street

With the advent of independence of Ukraine and new economic relations of the free market, the architecture of the historical center was overwhelmed by a new wave of reconstruction, or more precisely, extension actions: entrance elements of commercial establishments built into the lower floors began to appear widely. New porches, stairs, ramps, extensions of entrances to the basement or ground floor, window-shop “aquariums” are absolutely inconsistent with the original architectural concept of historical buildings (Fig. 2, 3).

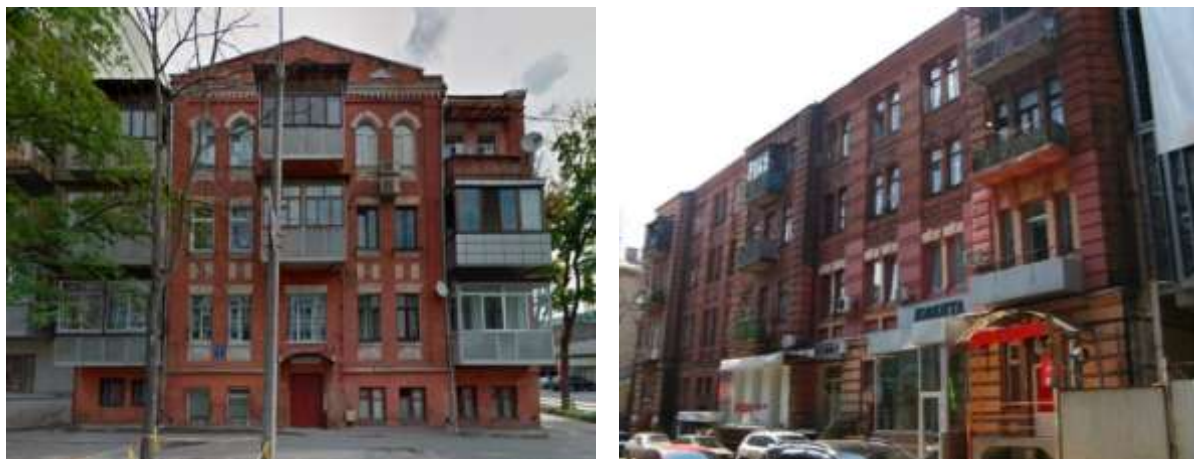
Fig. 3. Disharmonious elements of facades: replaced windows, doors, heavy loggias, extensions:
5 M.Yohansena St.; 5 Dontsya-Zakharzhevskoho St.

On the upper floors this process has evolved into “reconstructions” of balconies and loggias that are completely inadequate to the original conceptual characteristics of the facades, with replacement of fencing, cladding, materials, proportions, and violation of all possible compositional and stylistic patterns (Fig. 3).

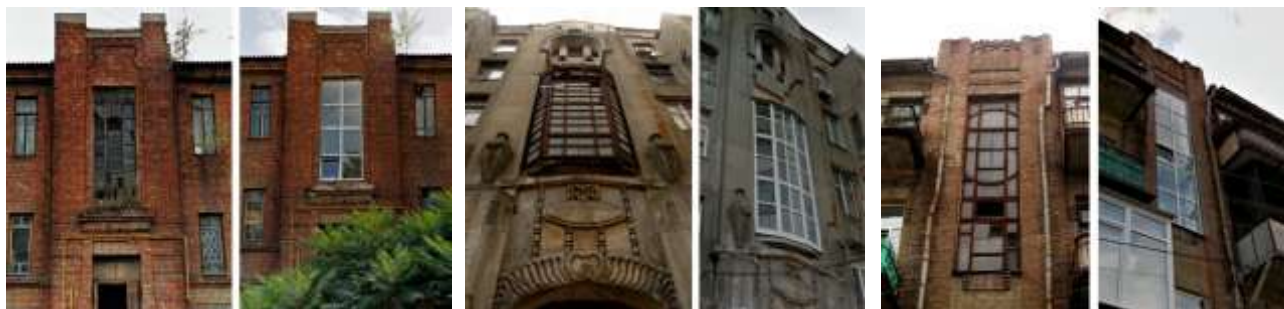
Fig. 4. Replacement of timber window sash structures with loss of the pattern of divisions (left to right): 30 Hromadyans'ka str., 20 Mykolaivska str., 14 Vorobiova St.

Among Kharkiv Art Nouveau buildings, unfortunately, it is easier to list examples of window sash structures lost in the process of “renovation”, often in the glazing of staircases of former multi-story buildings: for example, over the last couple of decades, original windows have been lost in buildings on 30 Hromadyans`ka str., 20 Mykolaivska str., 14 Vorobiova str. and many others, including architectural monument buildings (Fig. 4).

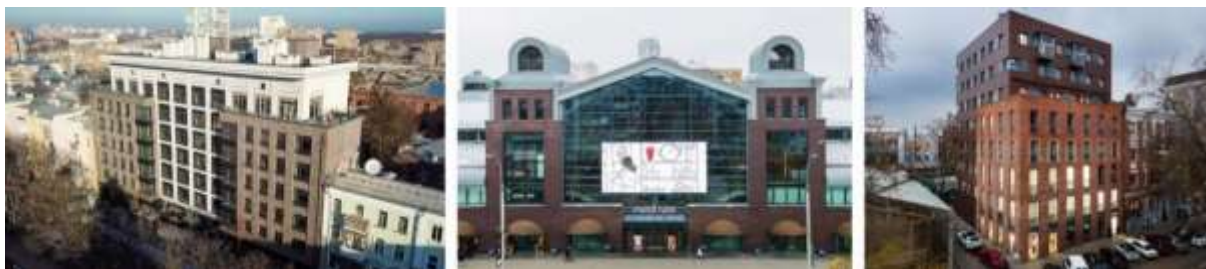
Fig. 5. Brickwork (and its imitation) in modern architecture of Kharkiv
(left to right): NODUS residential complex, 4 Kultury street, Sumsky Market building on 8 Kultury street;
Heirloom multifunctional building on 58 Chernyshevs'ka street

Positive examples of new buildings with brickwork or its imitation as a decorative component are the NODUS residential complex and the Sumsy Market building on 4 and 8 Kultury street, respectively; the Heirloom building on 58 Chernyshevs'ka street. In these examples, the brickwork surface is characterized by mosaicism, but its volumetric plasticity is minimal. (Fig. 5)

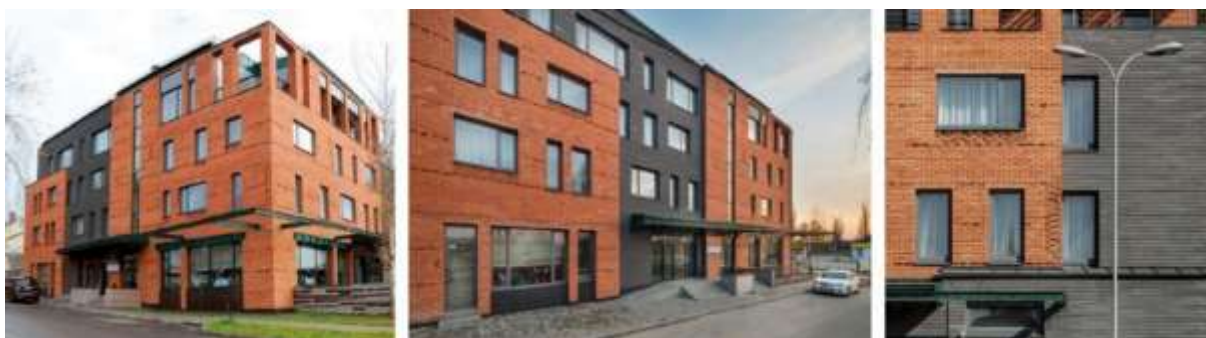
Fig. 6. Brickwork in modern architecture of Kharkiv: Villa Four Rooms, Kuznets'ky Viizd, 27

The Villa Four Rooms Hotel building, Kuznets'ky Viizd, 27 (2012 / Studio Ilchenko) stands out for its work with brick. The volumes of the building are highlighted by the color of the brick – classic “ceramic red” and more modern, gray. Inside the “red” part, some rows of masonry recede into the depth of the wall, forming curbs and pixel play. (Fig. 6):

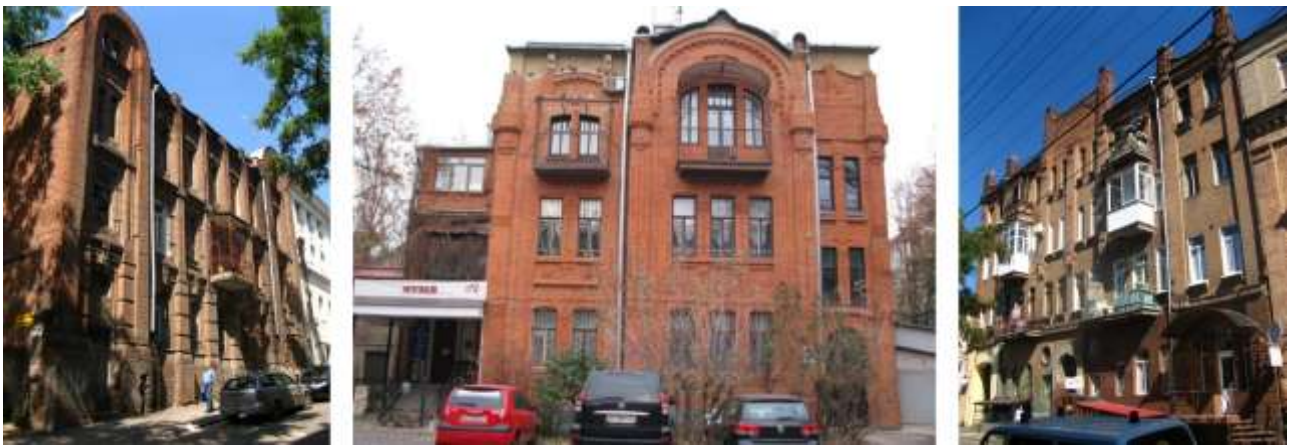
Fig. 7. Typical examples of Art Nouveau architecture in Kharkiv with brick facades (left to right):
10 Vorobyova str.; 81a Myronositskaya str.; 6 Lopans'ky lane

The second subgroup is represented by buildings in which the volume of plaster "inclusions" on the facade tends to zero, however, the facades have complex plasticity of masonry, abundant in brick decor, with a large number of figured volumetric elements, and rhythm which is multiple and subordinate to the size of the brick. Typical examples among the architectural monuments of local significance are shown in Fig. 7-8.

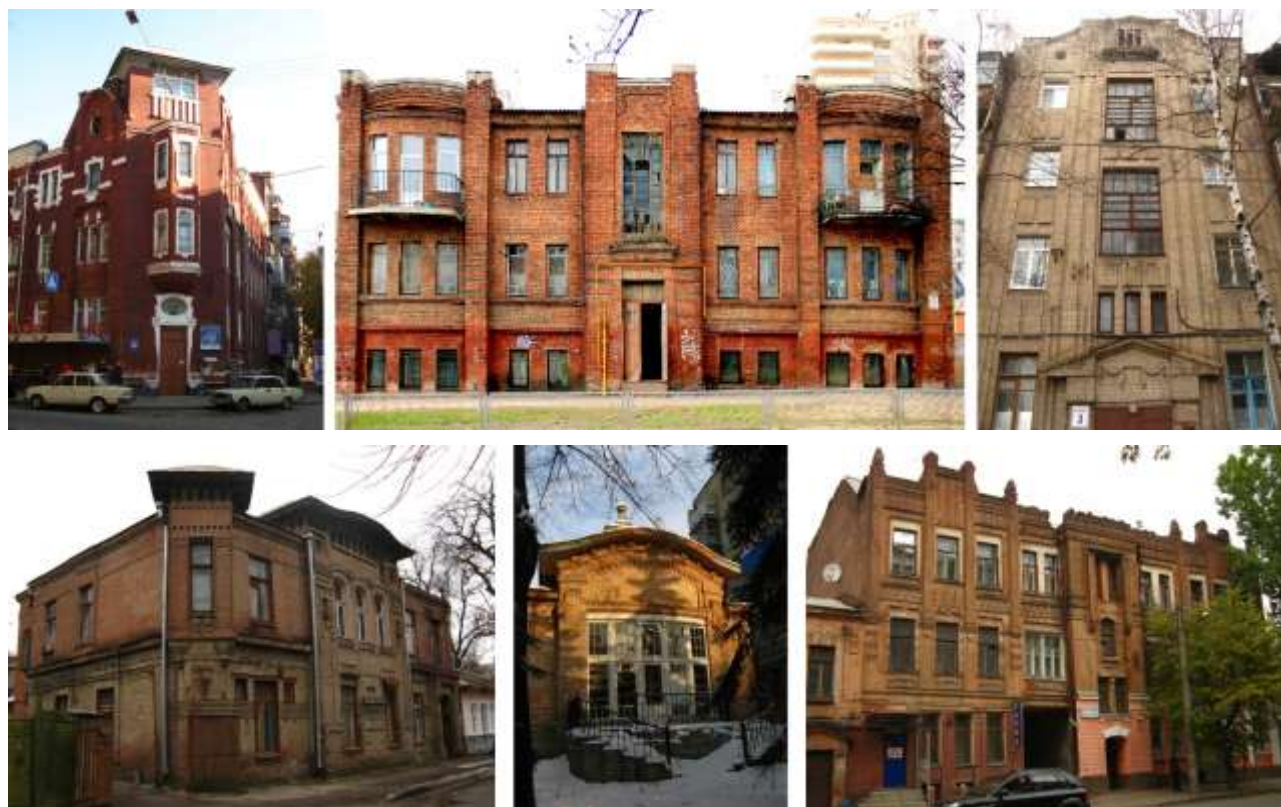
Fig. 8. Typical examples of Art Nouveau architecture in Kharkiv with brick facades (left to right): 92 Skovorody str.; 30 Hromadianska str.; 3 Potebni str.; Mansion of the architect Velichko in Yuryevsky Lane, 12; Migrin mansion, 35 Svobody str.; 5 G. Tarasenko str.;

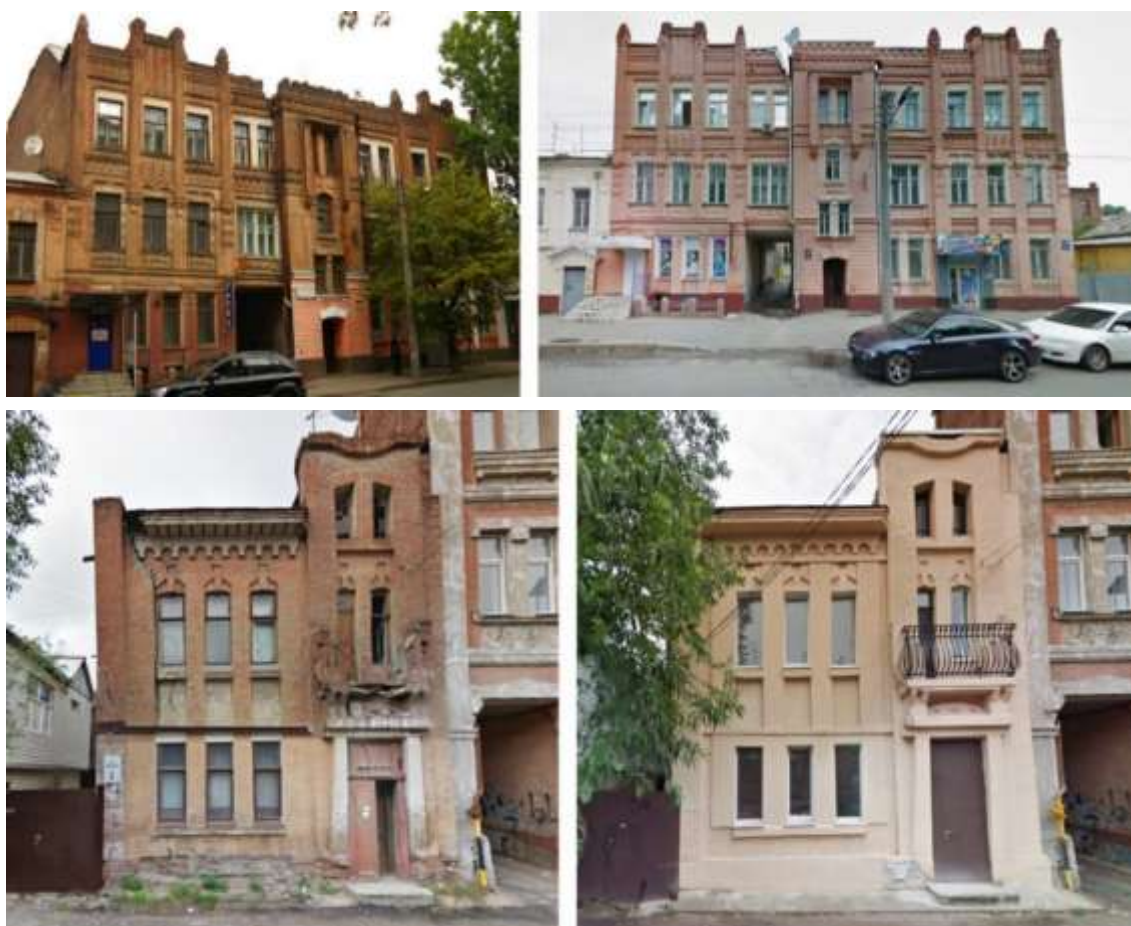
Fig. 9. Simplification, "posterization" and "flattening" of facades with a single color paint:
5 H.Tarasenka Str. (top) and 8 Prymerivska Str. (bottom)

Moreover, the choice of colors for painting facades is extremely controversial. When a building façade with variations of terracotta hues is turned bright pink, green, flesh-beige - such color solutions, although they brighten and visually lighten the facade, still reduce it to some artificial "cardboardness". Painting with a uniform monochromatic color of any, even earthy, range, even with highlighting and painting fragments and details in a contrasting, but quite often - in a nuanced color to the background - levels out all the charm and sophistication of individual living material, replacing it with a monolithic mass with tints, as if "cast" in a relief mould form (Fig. 9).

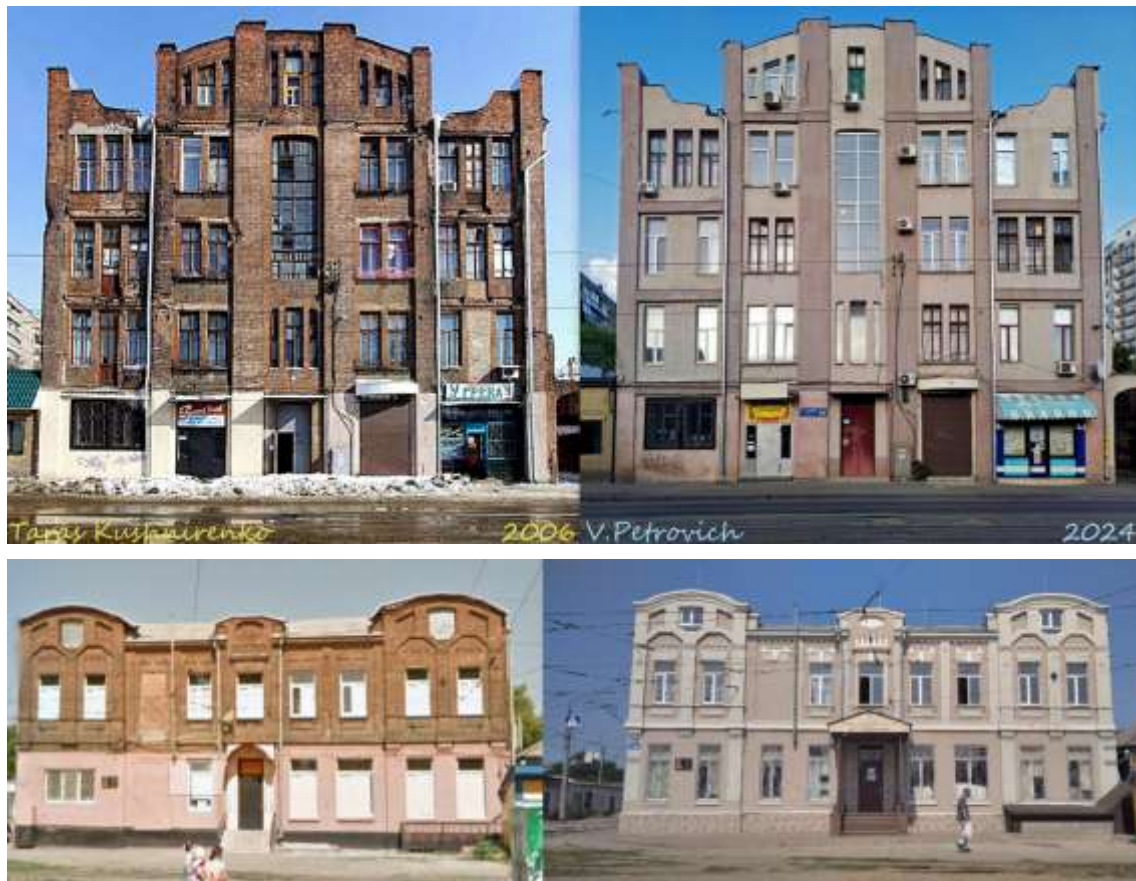
Fig. 10. Art Nouveau buildings plastered and painted in the 2010s:
3a Hrekivs'ka St. (top) and 142 Moskalivs'ka St. (bottom)

However, much more dangerous approach and result is given by works in which the building is not only painted, but also completely plastered. In section 4.2 "Modern state of construction of Art Nouveau architecture in Kharkiv" of the work [1, p. 188] "brick walls without a layer of plaster" are indicated as one of the types of the main "violations and destruction of Art Nouveau objects in Kharkiv". One cannot but agree that in a number of cases the destruction of the plaster layer of facades, sometimes along with the loss of stucco decor, is an example of the degradation of buildings. However, without such specification, this phrase can be interpreted as a justification for the widespread plastering of brick facades due to their "inferiority". It is regrettable that examples of such an algorithm already exist (Fig. 10).

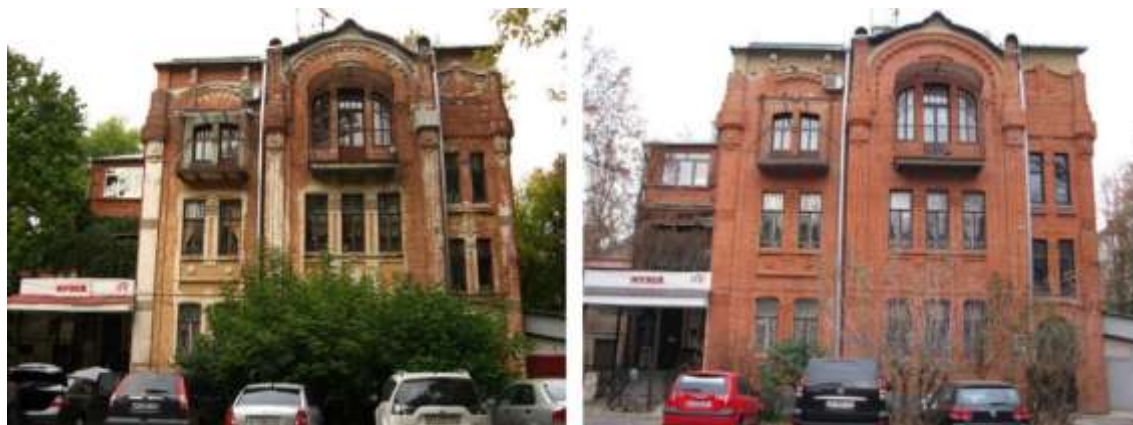
Fig. 11. An example of the facade of an Art Nouveau building with figured brickwork, cleaned by sandblasting – 81A Myronosits'ka st. - 2009 (left) & 2015 (right) photos

At the same time, even among the Art Nouveau monuments mentioned in Kharkiv, there are examples of successful work with the manifestation of original brickwork. Until the 2010s, the façade of the building on 81A Myronositska st. bore traces of several repaints, but was processed by sandblasting, revealing the original brickwork and the integral form of the façade, which did not lose, however, the play of small masonry plasticity. (Fig. 11)

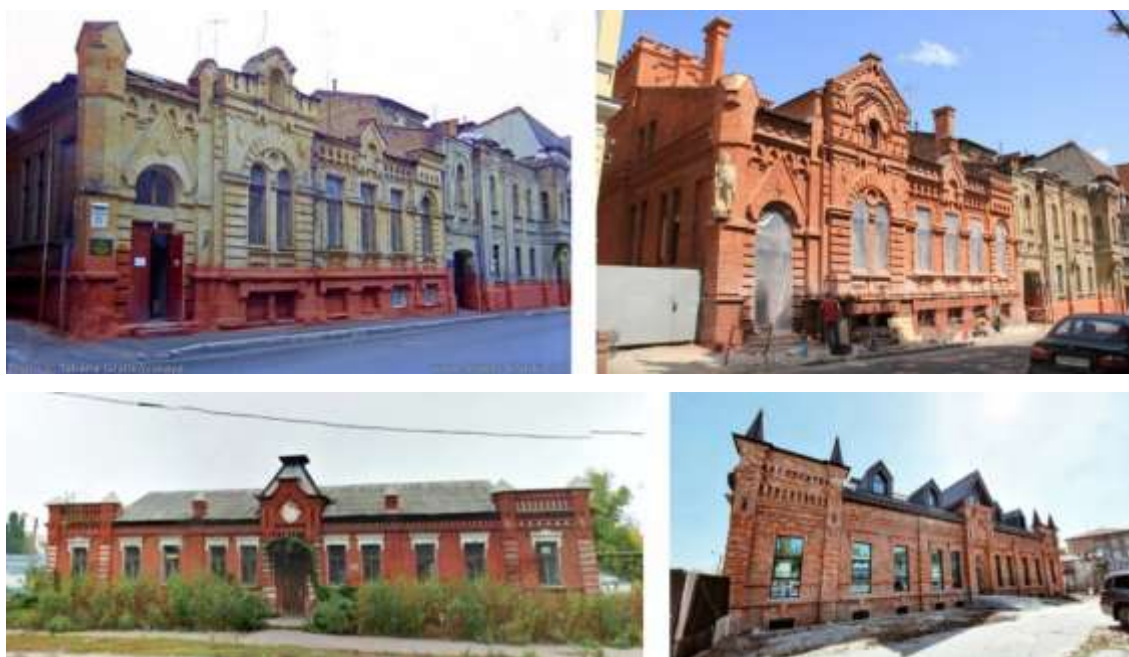
Fig. 12. Examples of reconstruction and renovation with “exposure” of brickwork in Kharkiv: buildings on 25 Darvina street, (top, 2000 and 2012 photos) and 30 Shevchenko Str. (GooglePanoramas 2015 and photo 2019 from the resource “Alluring Kharkiv”)

Examples of historic buildings in the city in other styles include the reconstruction of a mansion at 25 Darwin st., with the removal of layers of unsuitable paint from its facade, and the renovation and addition of buildings at 30 Shevchenko st., where a picturesque brick surface was revealed under a single-color red painted facade with white strokes, (Fig. 12).

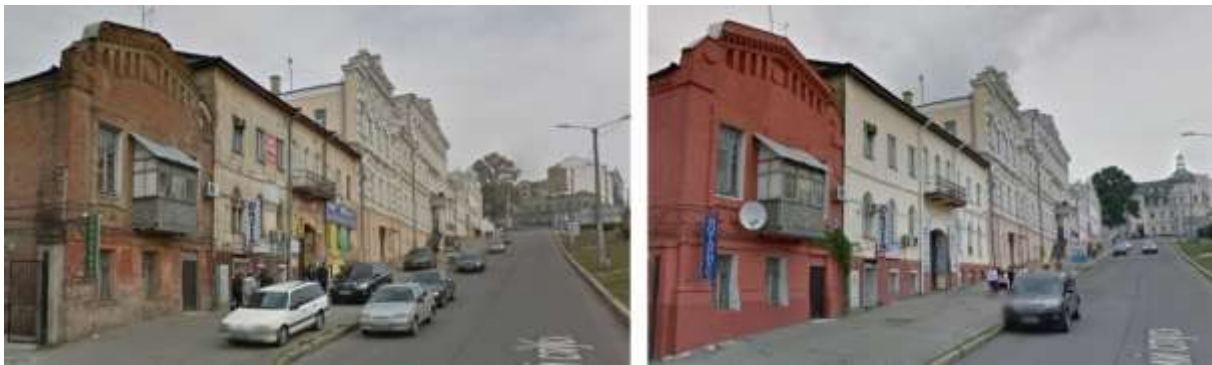
Fig. 13. Building in the brick Art Nouveau style in the environment: “natural” state of the façade (left) and painted in a single color (right) (Bursatsky descent, 8, Kharkiv)

We have completed a graphic reconstruction of the façade of a residential building in the brick direction of the style on 8 Bursatsky descent. Fig. 13 shows a comparison of the previous and current appearance of the façade “in the environment” of the nearest buildings on the street. The graphic reconstruction is shown in Fig. 14. The building is not an architectural monument, but is located on a busy street in the city center, in one of its most ancient parts, near the Pokrovsky Monastery and the former “bursa” - now known as the Kharkiv State Academy of Culture.

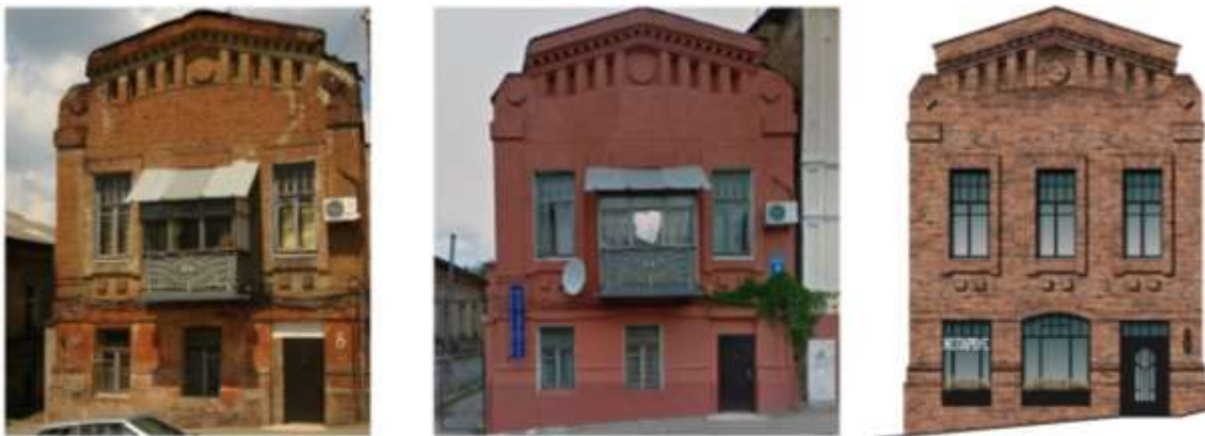
Fig. 14. Proposed facade reconstruction of “brick art nouveau” style building on 8 Bursatsky Descent, Kharkiv. 2008, 2015 photos & graphic reconstruction option of the façade

The façade of a compact two-story building, which has long since lost its main “emphasis” – a wide window with a bow arch in the center of the first floor (traces of a blocked-up opening, narrowed to a rectangular window, are visible), instead “acquired” a very controversial addition in the form of a glazed loggia, covered with asbestos-cement or metal corrugated sheets. The metal fencing of the loggia clearly has features of Art Nouveau, but in its current design it is very difficult to definitely consider it authentic. In addition to such “surgical” effects, the façade was also painted a solid saturated red-terracotta color in the first half of the 2010s, which, in our opinion, negatively affected its visual and environmental qualities.
